**PROJECT:** Product Check - P.O. No. 7001-95000  
 53<sup>rd</sup> Street Yard

**SAMPLE DESCRIPTION:** Crushed Concrete  
 (Base Material)

**LIMEROCK BEARING RATIO TEST**

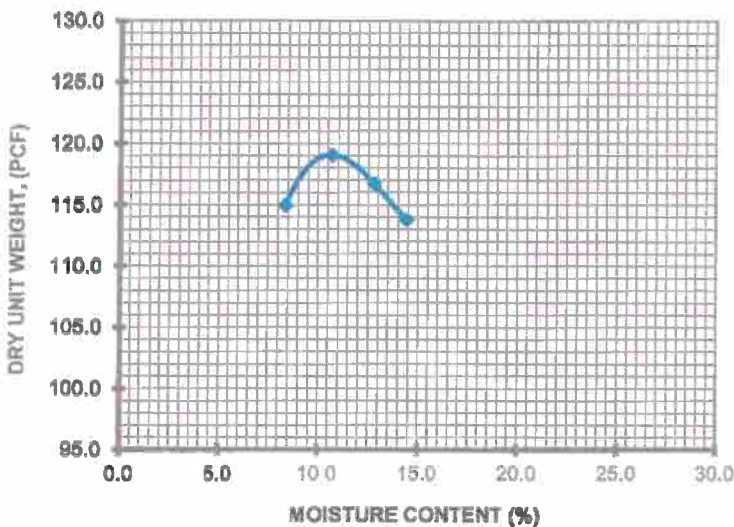
TEST METHOD: FDOT FM 5-515

**MAXIMUM LBR VALUE (%):** 226

**MAXIMUM DRY DENSITY (PCF):** 119.1

**OPTIMUM MOISTURE (%):** 10.7

**SOIL DESCRIPTION:** Crushed Concrete

**SOAKING TIME (HRS):** 48±4
